March 12, 2024

Subject: Lake Watch's response to Dominion's response (Sept. 22, 2023) to FERC letter (July 26, 2023) requesting information on allegations of improper buffer clearing at Vinge Rd. on Lake Murray , in Newberry County

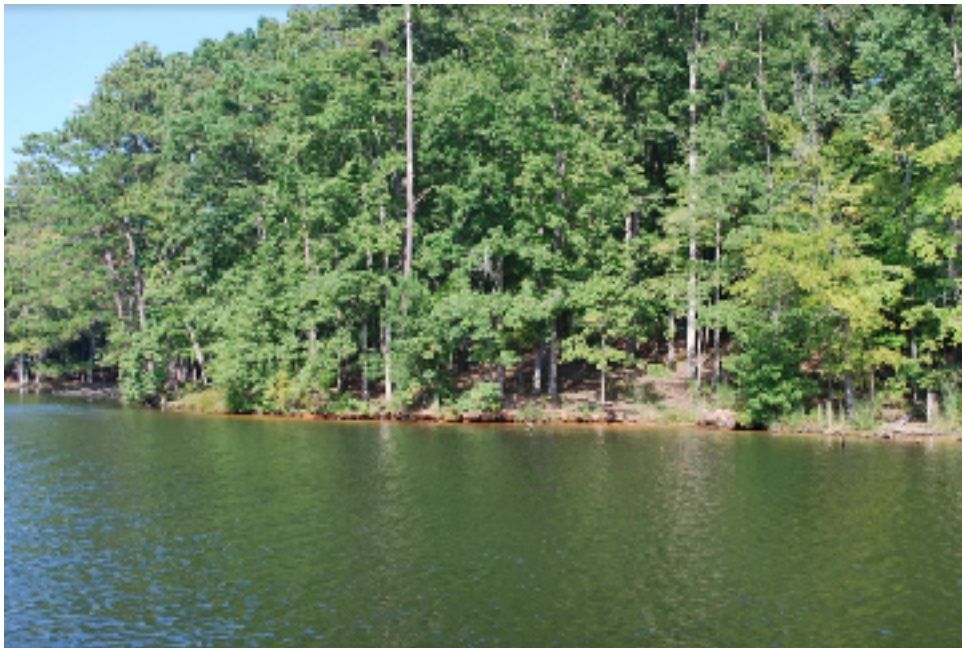
Please reference attached photos. Photo 1 shows undisturbed shoreline adjacent to Vinge Rd. Photo 2 shows shoreline stabilization using rip rap. Photo 3 shows residence adjacent to the disturbed buffer.

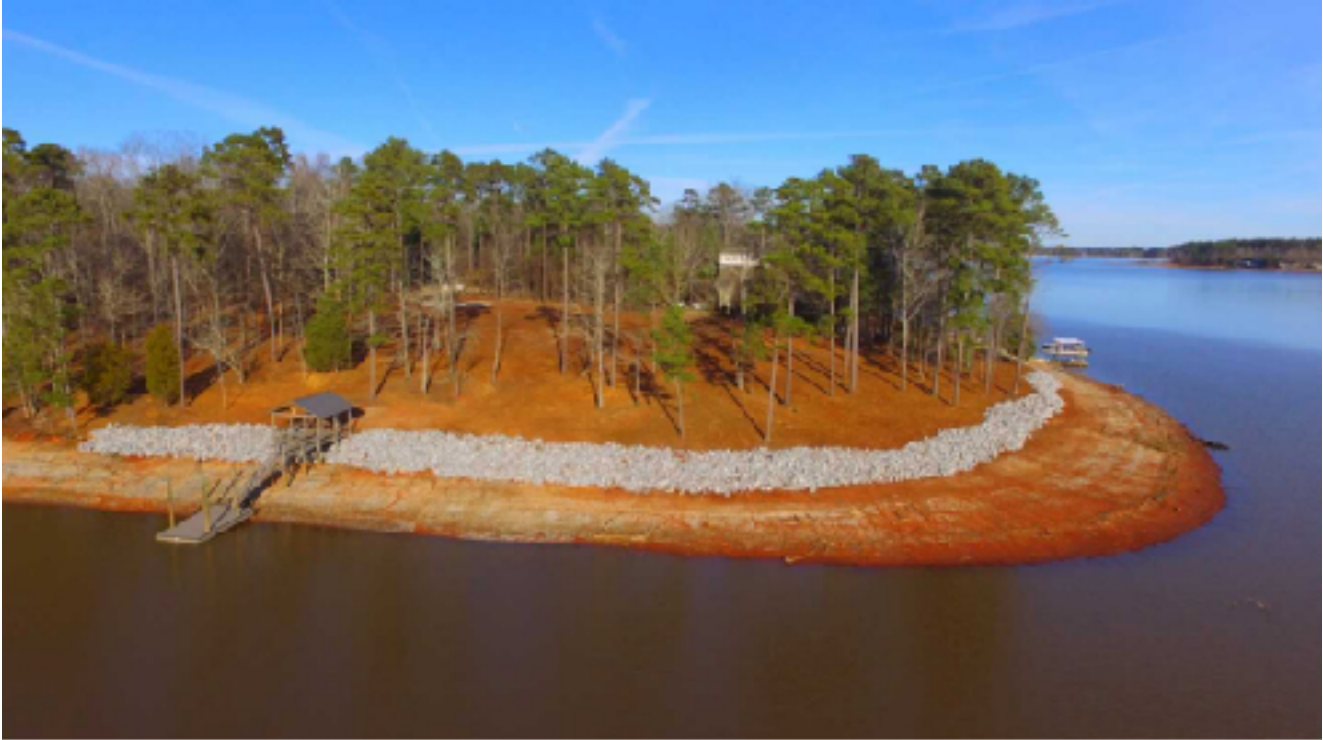
Rip rap was installed exclusively along this entire shoreline rather than using bioengineering methods recommended by the Plan. The Plan calls for using bioengineering techniques if the slope is as flat as 2 to 1 or flatter. If the slope is steeper than 2 to 1, other more substantial methods (including rip rap) are considered. The shoreline in question, for the most part, has gentle slope which begins right below a small erosion scarf which occurs at the 358' contour. Thus a combination of bioengineering methods combined with rip-rap should have been used at this location.

Lake Watch request that the FERC require the licensee to adhere to the provisions of the 2007 Buffer Zone and Riparian Management Plan which will require re-planting of the entire buffer at the Vinge Road site with trees, scrubs, forbs and grasses as specified. Please contact me if you have any questions.

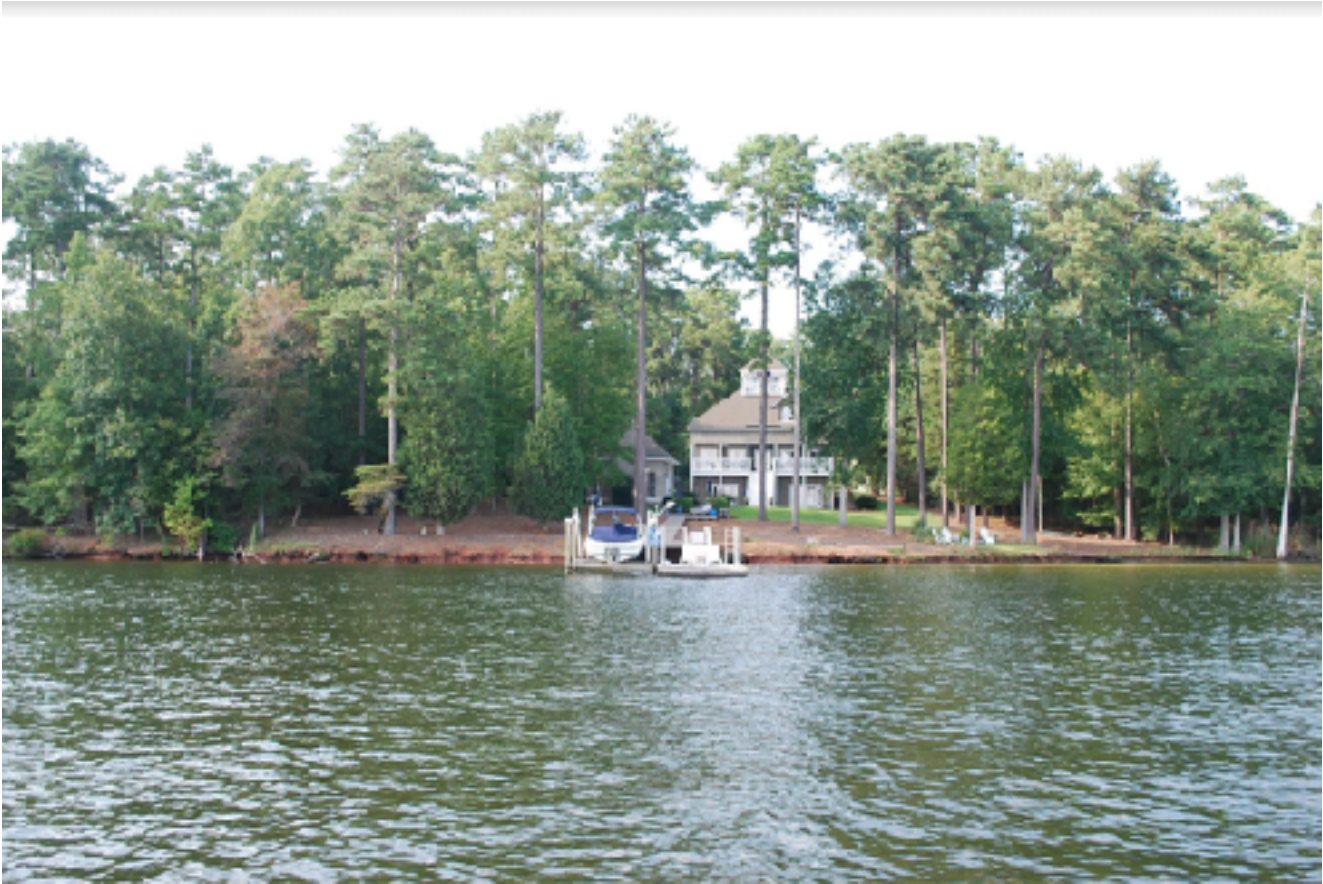
Dominion issued a permit allowing the property owner to clear everything except large trees within the 75' buffer and below the 360' contour. (The Plan which applies to all buffer zones established after 1984 and was implemented in 2007.) The Plan does not allow any clearing in the first 50' of the 75 buffer except to install a dock and pathway to a dock. Also some invasive species may be removed.)The licensee continues to argue that this property does not come under the 2007 Plan therefore qualifies for a brushing permit.
